GEUM ENVIRONMENTAL
CONSULTING, INC.

April 25, 2012

Subject: Clark Fork River Operable Unit of the Milltown Reservoir/Clark Fork River Superfund Site Pilot Streambank Treatment Project

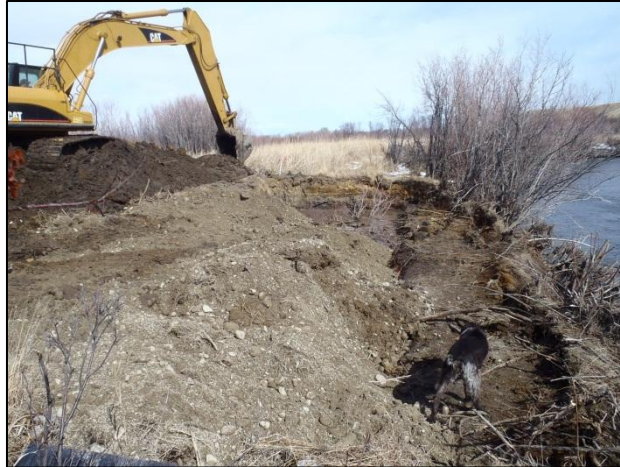
- Preserved woody vegetation is well rooted in the banks and rooted below excavation depth.
- The living roots observed in the excavation wall within two feet of the bank appear to be from plants that are also well rooted below the excavation depth.
- No bank sloughing or slumping of vegetation occurred during excavation. Leaving two feet of existing material intact appears to provide sufficient stability for preserved vegetation during excavation. Continued stability of vegetation should be monitored.
- The root crowns of preserved vegetation were at variable heights after excavation to the design top of bank elevation. Similar to the Type 2 bank treatment site, any vegetation greater than one foot above the top of bank design elevation was removed.

- No significant gaps in vegetation were present at this site after removal of vegetation above the design top of bank elevation. Because bank material is left in place, small gaps in vegetation (five feet or less) will not likely affect the stability of banks using the Modified Type 2 treatment.

- The native bank substrate consisted of clay loam.
- Based on observations of soil color alone (obvious soil contamination being bright orange or yellow in color), it appeared that excavation of material to the design top of bank elevation and within two feet of the bank resulted in removal of most contamination (soil profile seen at top of photo in Figure 7).

Based on these observations, it is recommended that wherever feasible the Type 2 bank treatment is changed to the Modified Type 2 bank treatment for final design. The Modified Type 2 bank treatment would have the following design elements:
